Case Study

Windermere

Mechanical Condition Report (Inspection)

Removal of PST Scraper Bridge & Repairs

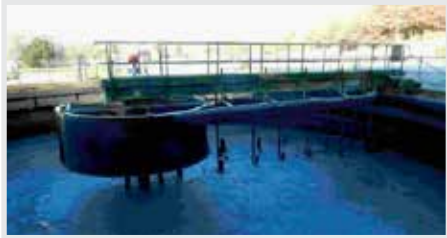
PST

Accumulation of rags on scraper support frame.

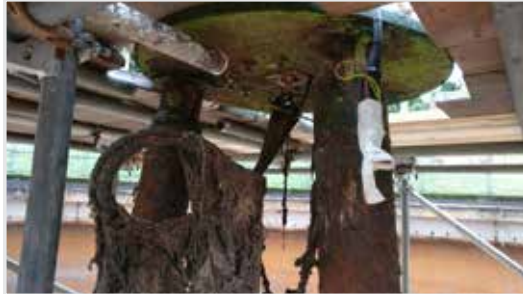
PST Bridge Tripod Support

Accumulation of rags on cables loop.

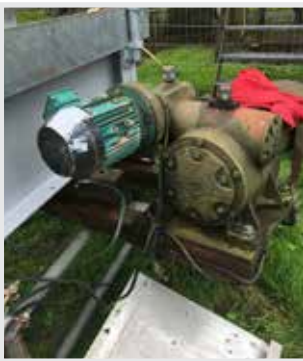
PST Drive Motor & Gearbox

Note rotation monitor disconnected.

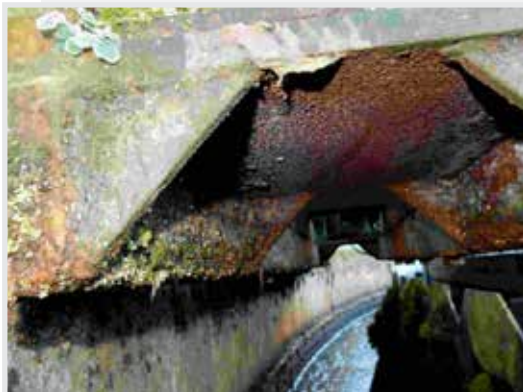
Corrosion on the underside of PST trolley wheel & framework that supports the scraper bridge.

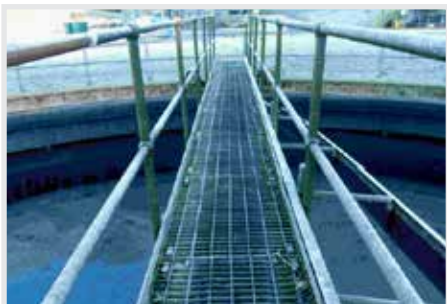
PST Bridge Deck

No extensive surface corrosion visible.
The scum scraper. Appears to be undamaged.

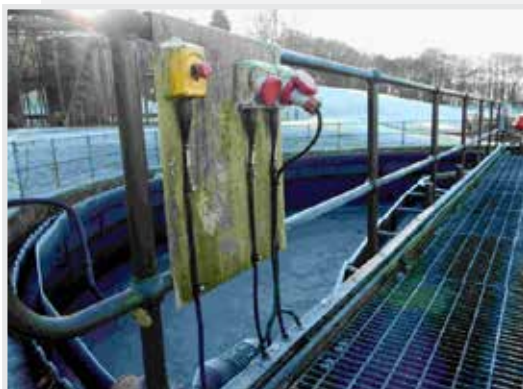
Signs of surface algae growth on metal components.

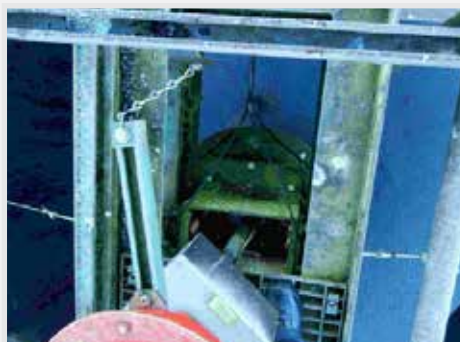
No decking or cover around centre spindle.

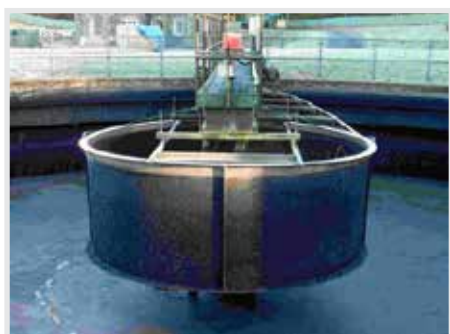
PST Inlet Baffle

The baffle visibly looks to be in sound condition with no cracks or delamination's.

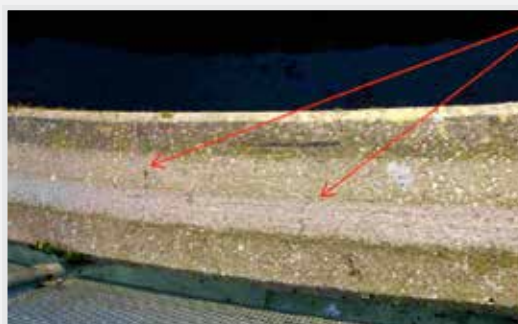
PST Inlet Baffle

Some surface cracking at intervals otherwise track is relatively smooth.

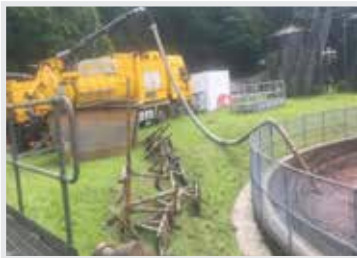
Drainage and empty surface water from PST Tank by a Vacuum Tanker.

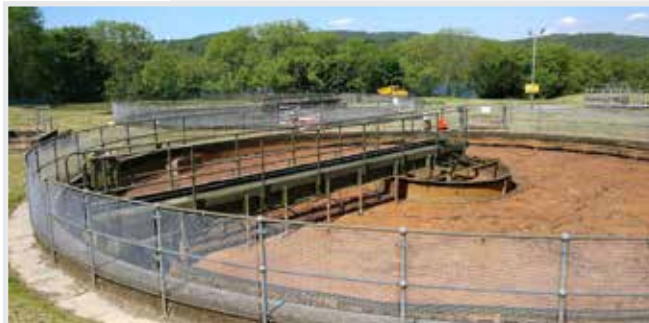
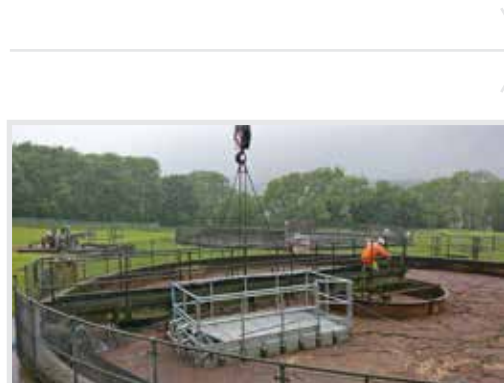
PST Bridge Tripod Support

Installation of a floating scaffold making an easy access to the scraper bridge to remove the fixings.

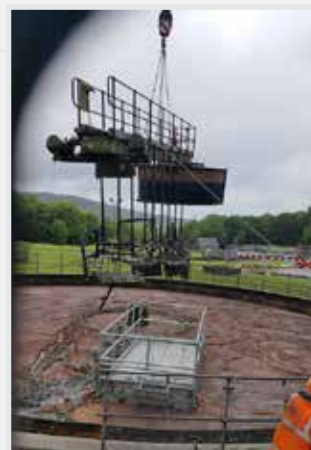
Removal of PST bridge by crane.

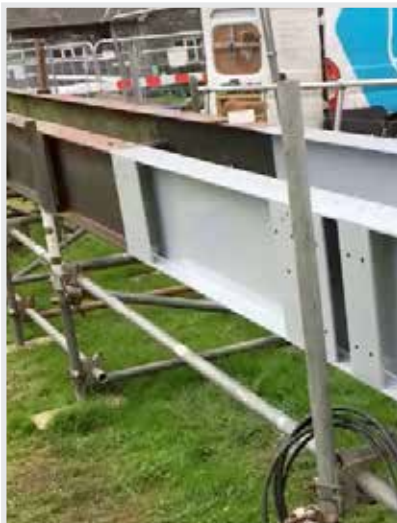
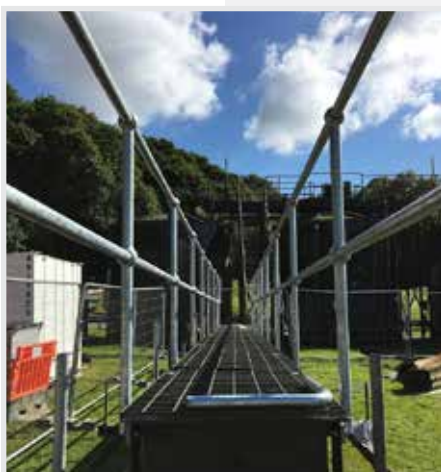
Cleaning & Painting the Bridge

Installation of the new handrail and repairing to the deck.

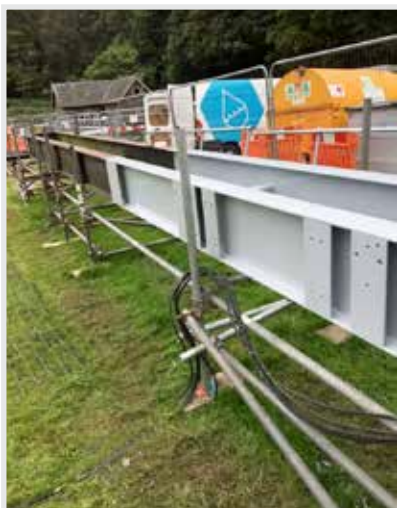
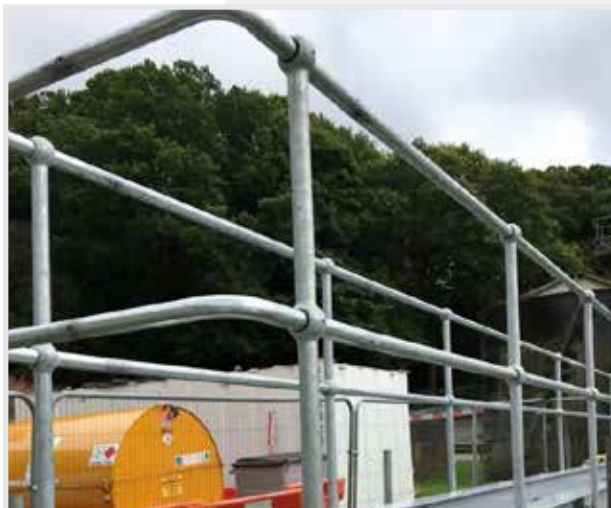
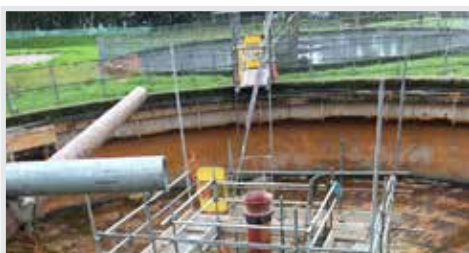
Installation of scaffolding inside the tank, access scaffolds were installed from ground level down into base of tanks and central tripod.

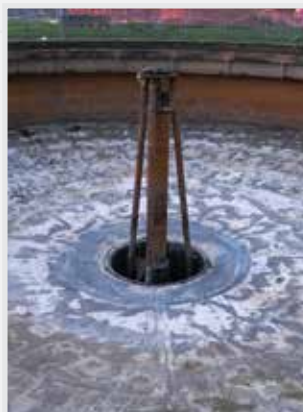
Removal the existing tripod and piperwork.

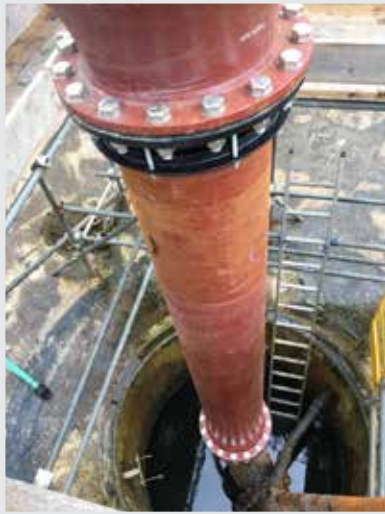
Installation of the new tripod and the new pipework. The installation was performed using a mobile crane for the lift and correct placement, we then fixed to the surface.

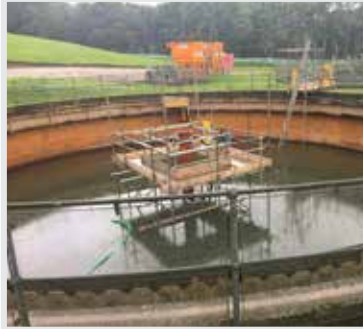
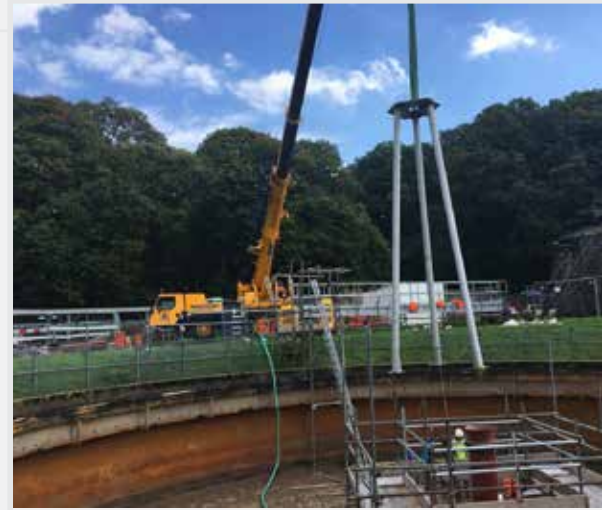
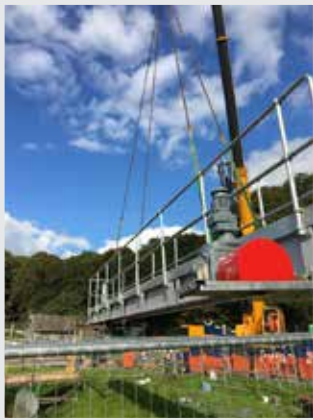
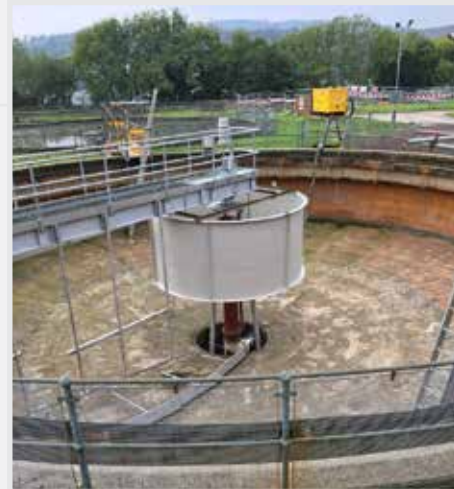
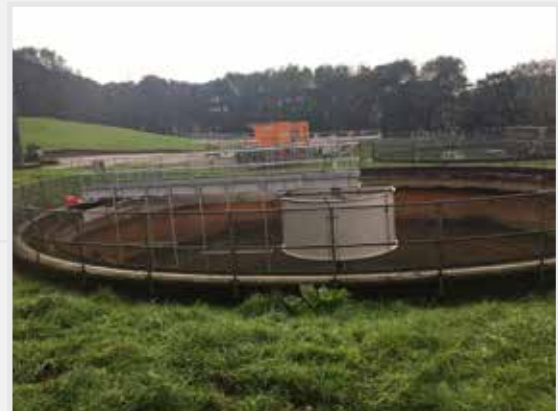
The Installation was completed and prepared for dry testing.
